Natural Heritage Investigations

Subject: Natural Heritage Assessment Study Update for the Hamlet of Colgan, Township of Adjala-Tosorontio, County of Simcoe

APPENDIX A
Site Photographs

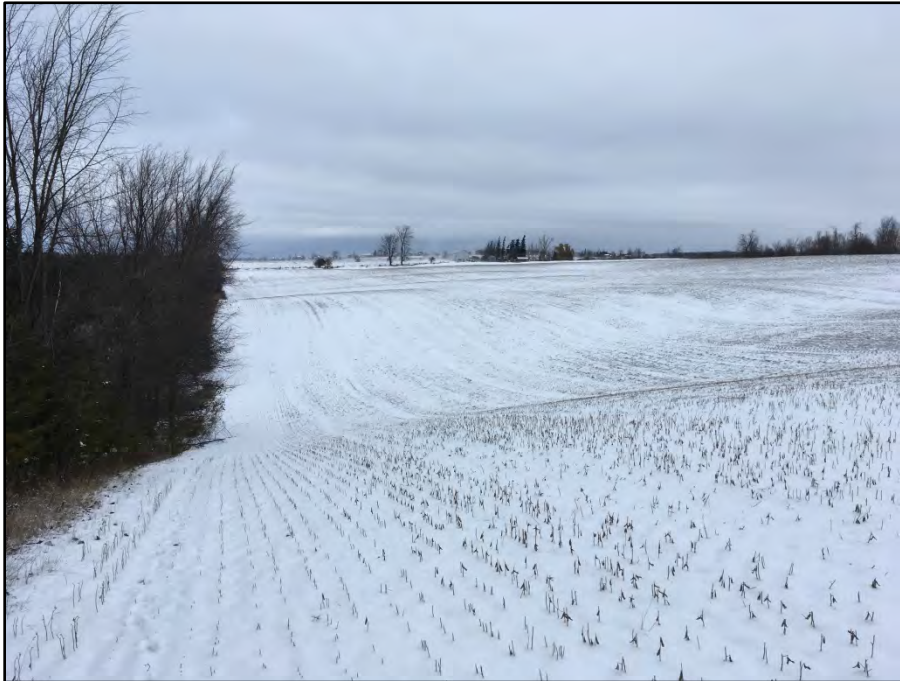
1. Proposed WWTP location contains agricultural fields (soy beans) along the east and the natural valley corridor along the west.

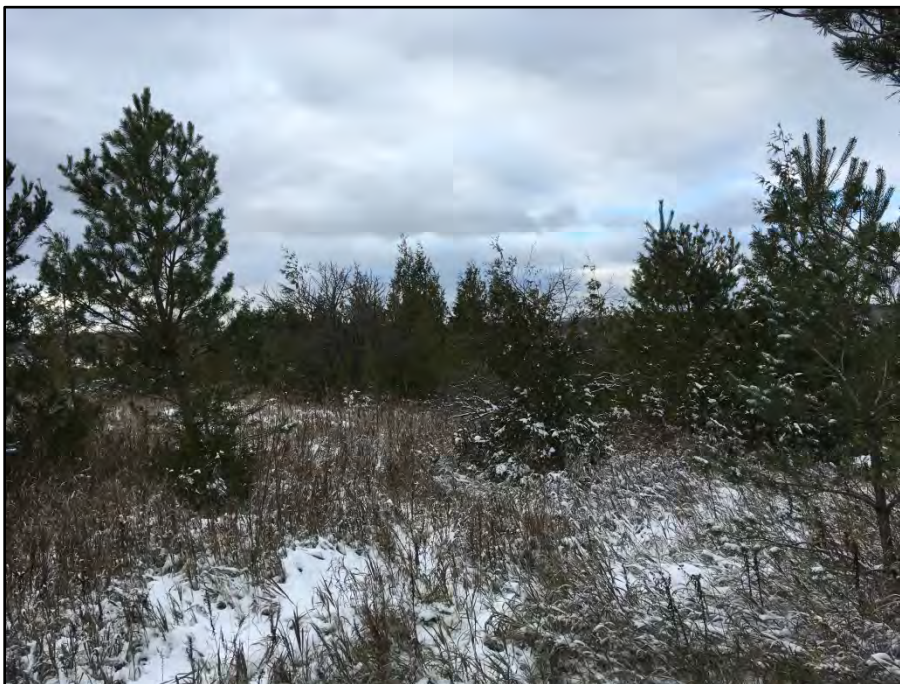
2. The valley corridor adjacent to the proposed WWTP contains an Eastern White Cedar –Hardwood mixed forest along the top of the valley as well as the northern portion of the property.

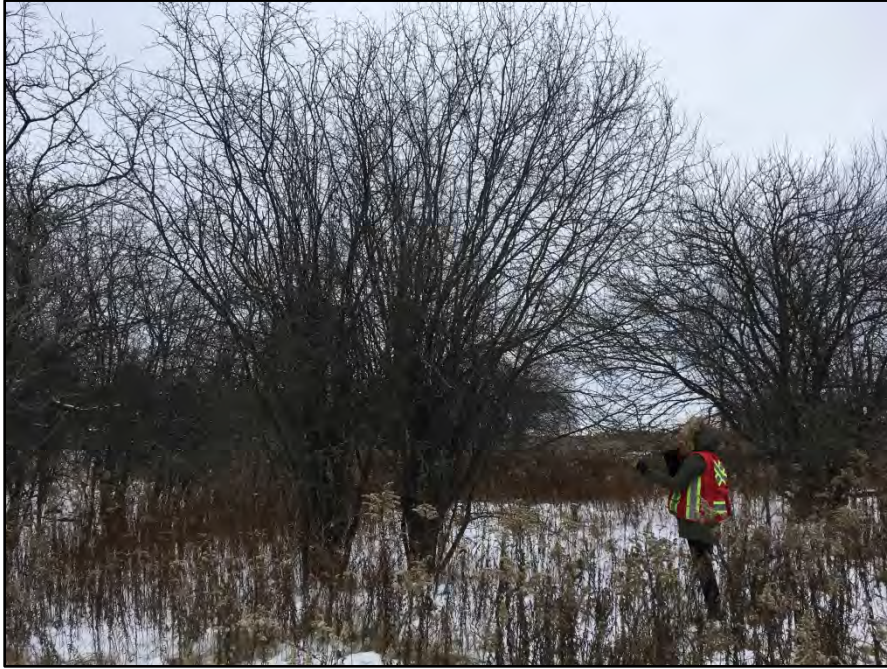
3. The valley lands adjacent to the proposed WWTP contain a deciduous shrub ticket.

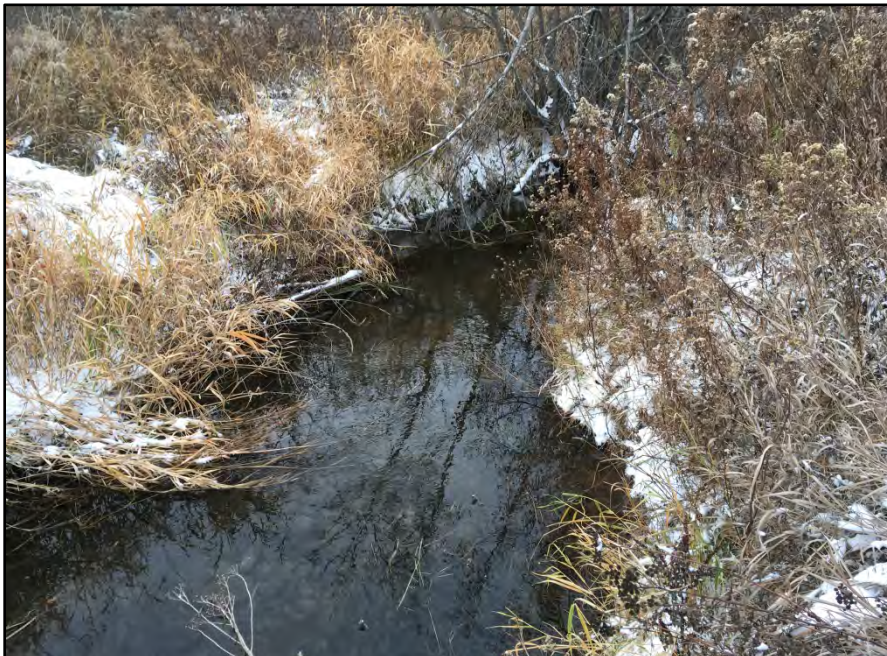
4. Keenansville Creek located within the valley lands (adjacent to the proposed WWTP) is a low gradient creek system which meanders through this valley corridor towards Keenansville Road.

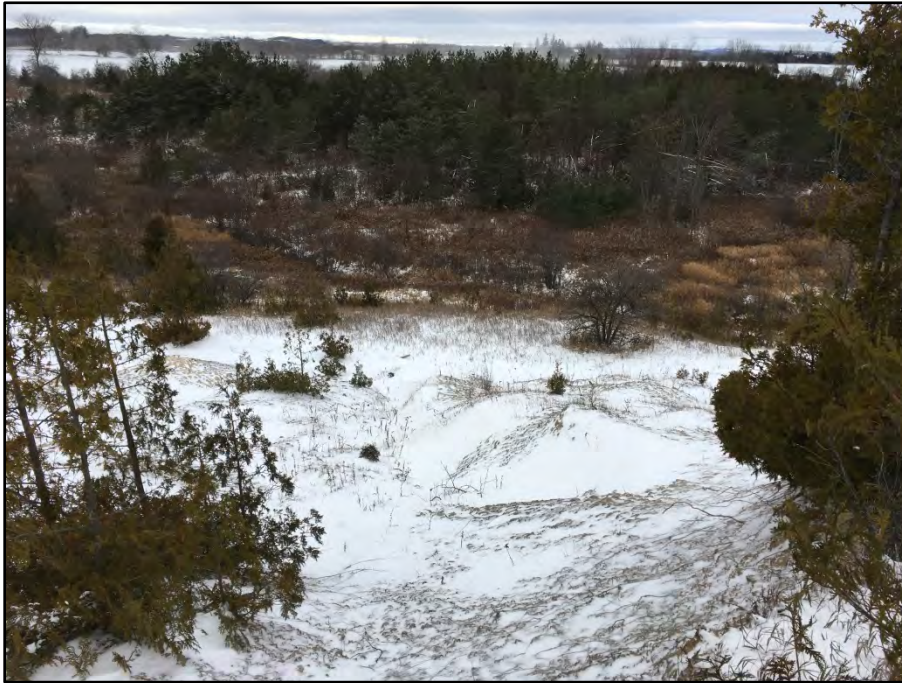
5. Looking west on exposed valley slope on the east side of Keenansville Creek. South of the proposed WTP facility location.

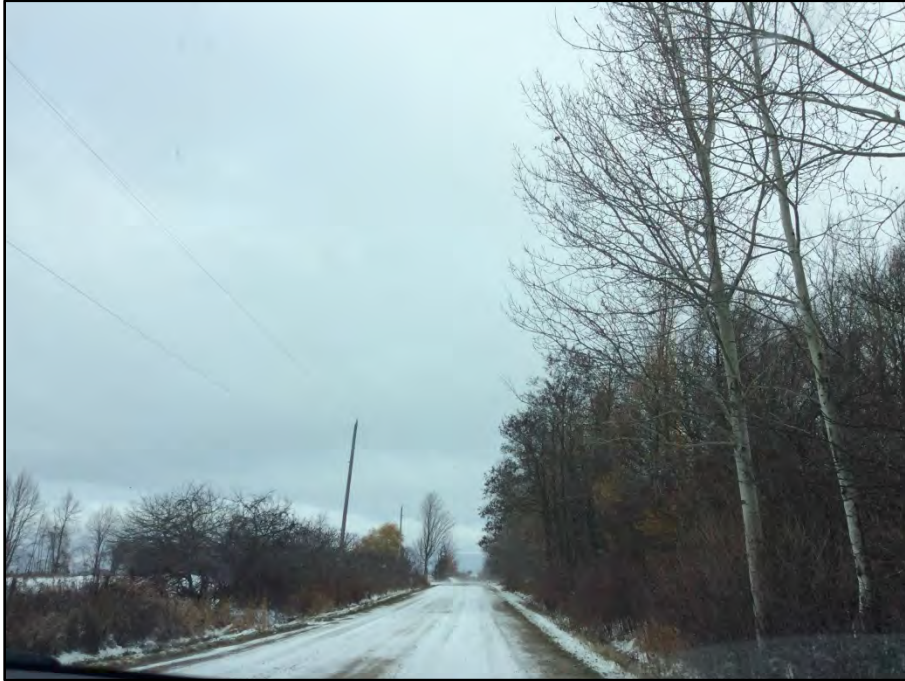
9. Tree Inventory along newly proposed forcemain route shows the majority of mature trees along the east side of 8th Concession Road.

To reduce the amount of impact to the residential trees along 8th Concession Road, as well as the adjacent wetland complex, it is recommended that the forcemain be installed along the west side of the road.

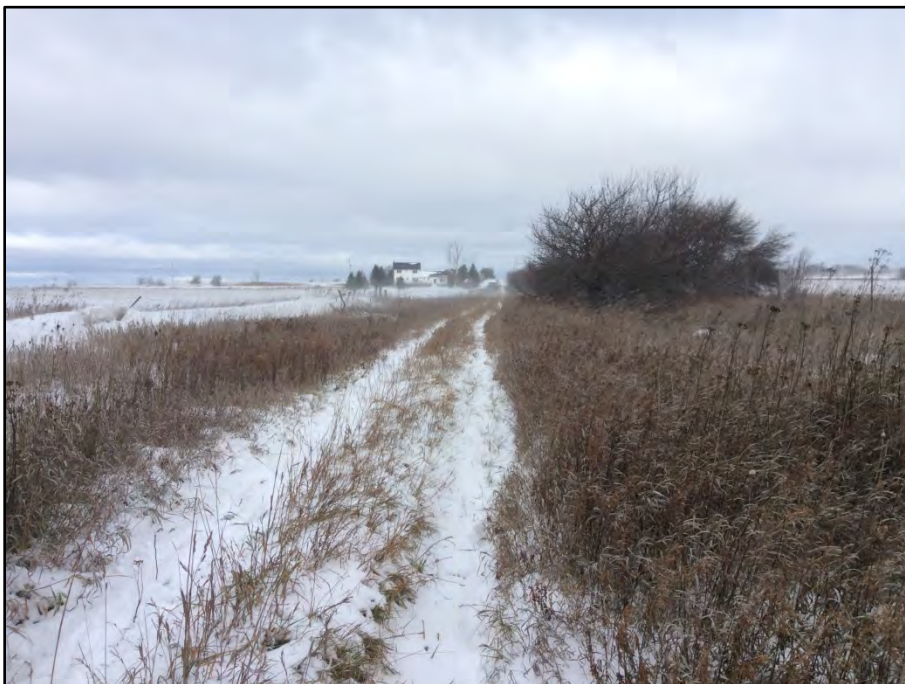
10. Tree inventory along the newly proposed forcemain route shows the existing vegetation within the road allowance.

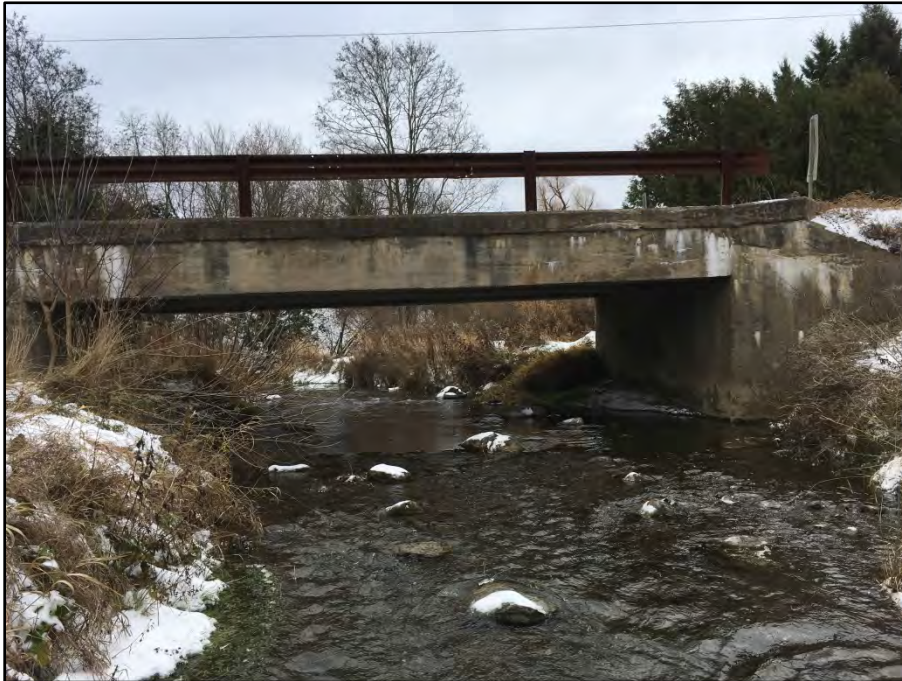
11. Outfall Location facing upstream towards Keenansville bridge. Riffle habitat with overhanging vegetation.

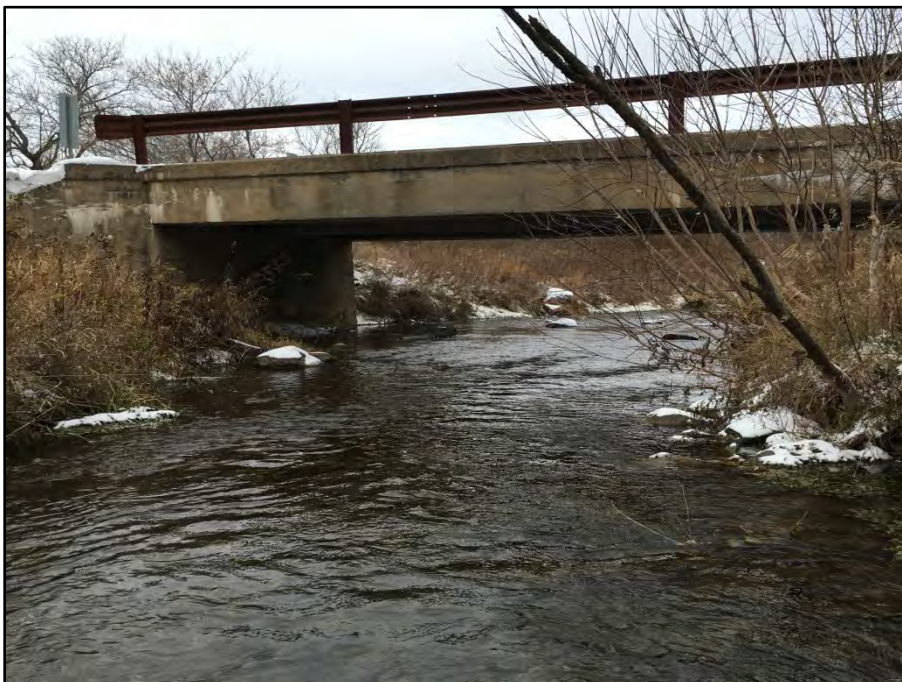
12. Outfall location facing downstream towards Keenansville bridge. Watercress present along the toe of the right bank.

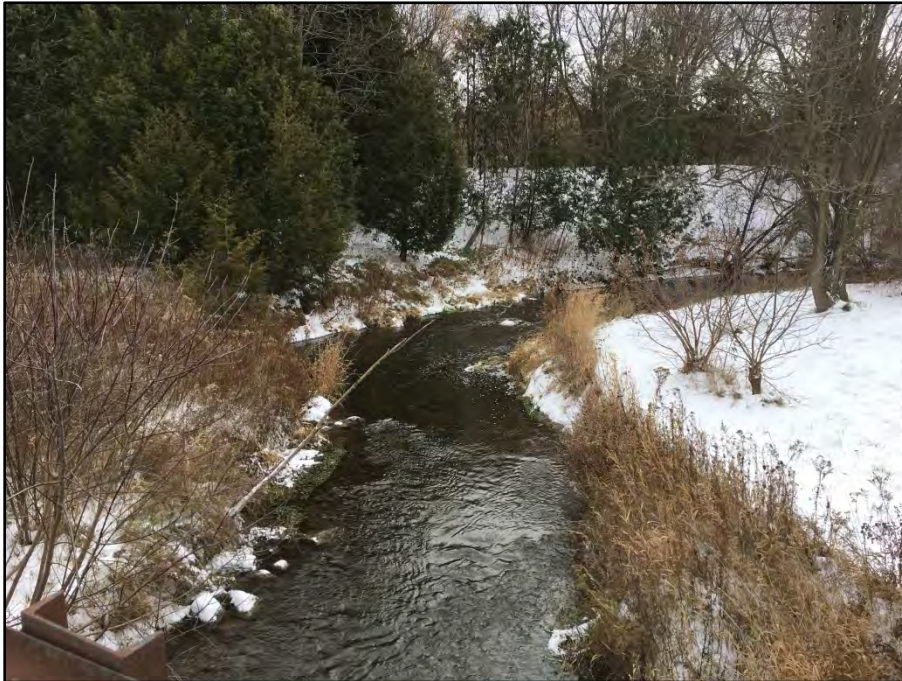
Bankfull widths in the channel ranged from 4.5 m to 7.0 m, with the widest section occurring underneath the existing bridge. The channel has migrated under the bridge, along the north edge of the western abutment. This migration may have occurred due to the lack of vegetation under the bridge, which causes some instability of the channel banks making them more susceptible to erosion and channel widening. No scour was noted at the edge of either abutment.

13. Bailey Creek, looking upstream from Keenansville Road Bridge.

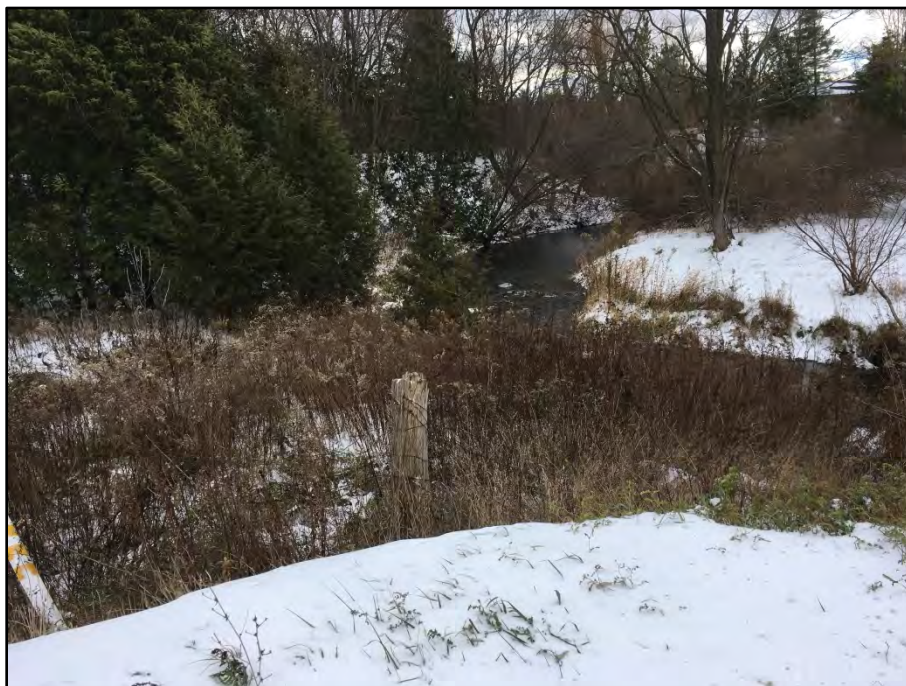
24. South side of Keenansville Road, looking upstream at Bailey Creek. Low sloped and highly vegetated.

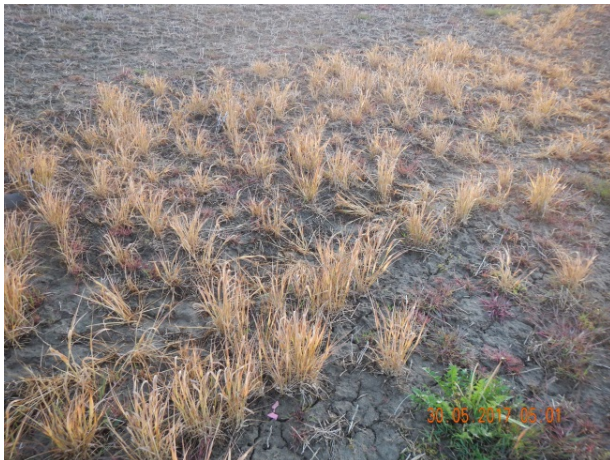
The northern fields were a combination of low lying weeds and old soy crops as seen in Figure 2 and 3. As discussed above, due to the lack of height and density of the vegetation, the field were considered inadequate habitat to support breeding for Bobolink and Eastern Meadowlark species.

FIGURE 2 Northern Field 75 m North of Highway 14- Sparse, Short, Weedy Vegetation

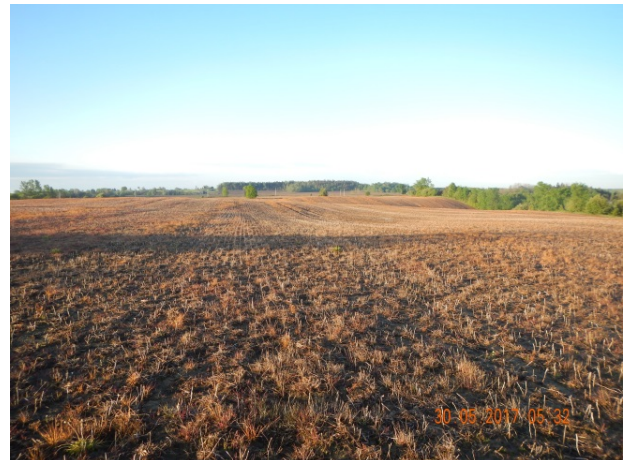
FIGURE 3 Northern Field near Northern Edge of Study Area Facing South - Old Soy Plants in Field

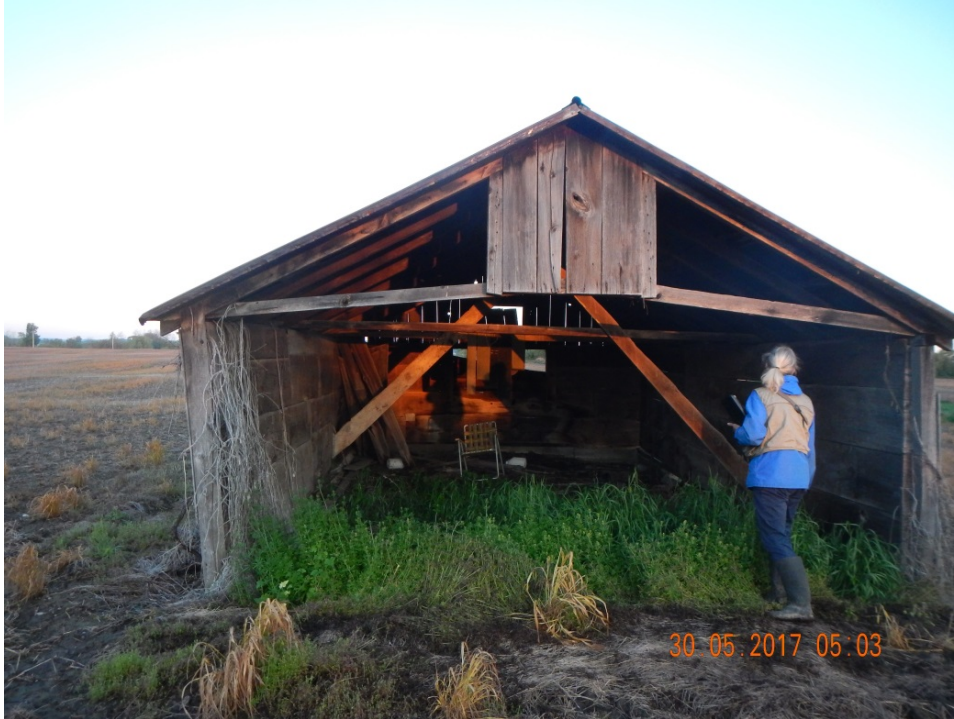
While completing the northern field area search, an old stable was found and investigated to confirm the presence/absence of Barn Swallow. The stable assessment resulted in the recording of two nests, most likely created by American Robin (Figure 4). No Barn Swallow nests were observed.

FIGURE 4 Old Stable Assessed for Barn Swallow Nests

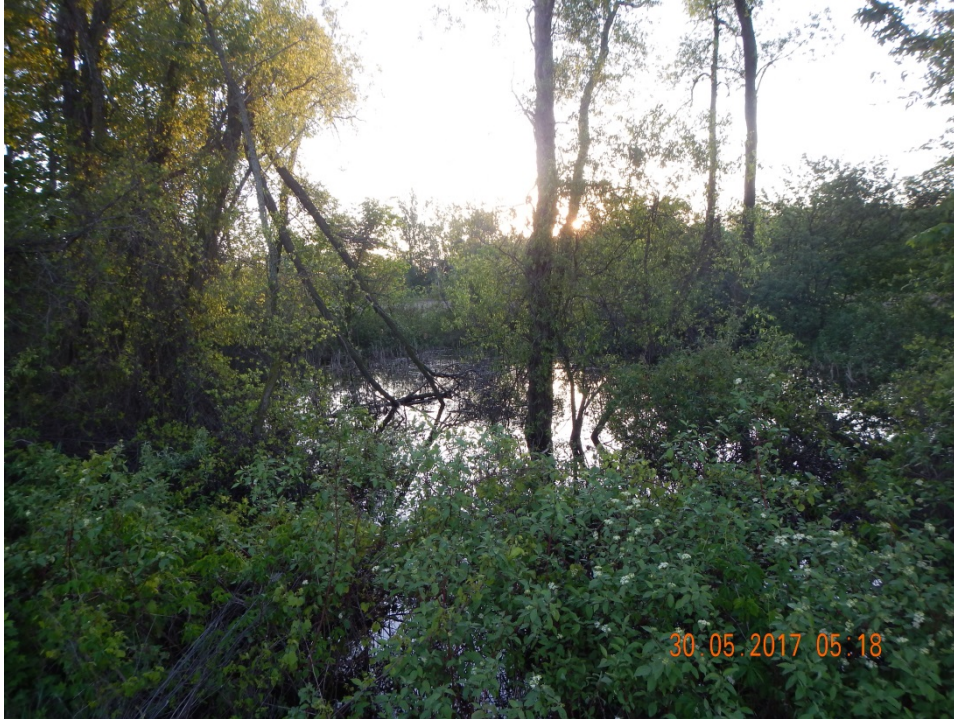
A point of interest within the northern fields is a wetland inclusion (POI #1; Figure 5) that appears to connect to the large wetland complex on the east side of Concession Road 8. Five species of birds were audibly observed using this wetland habitat (outlined in Table 1) including European Starling, Red-winged Blackbird, American Robin, Black-capped Chickadee, and Warbling Vireo. It was initially thought that this wetland inclusion may be potential habitat for Least Bittern (a SAR listed as threatened under the ESA), but upon investigation, it was deemed inappropriate due to the lack of tall emergent vegetation. Amphibian calls were also heard within the wetland including a Green Frog.

FIGURE 5 Wetland Inclusion along Northern Boundary of the Study Area

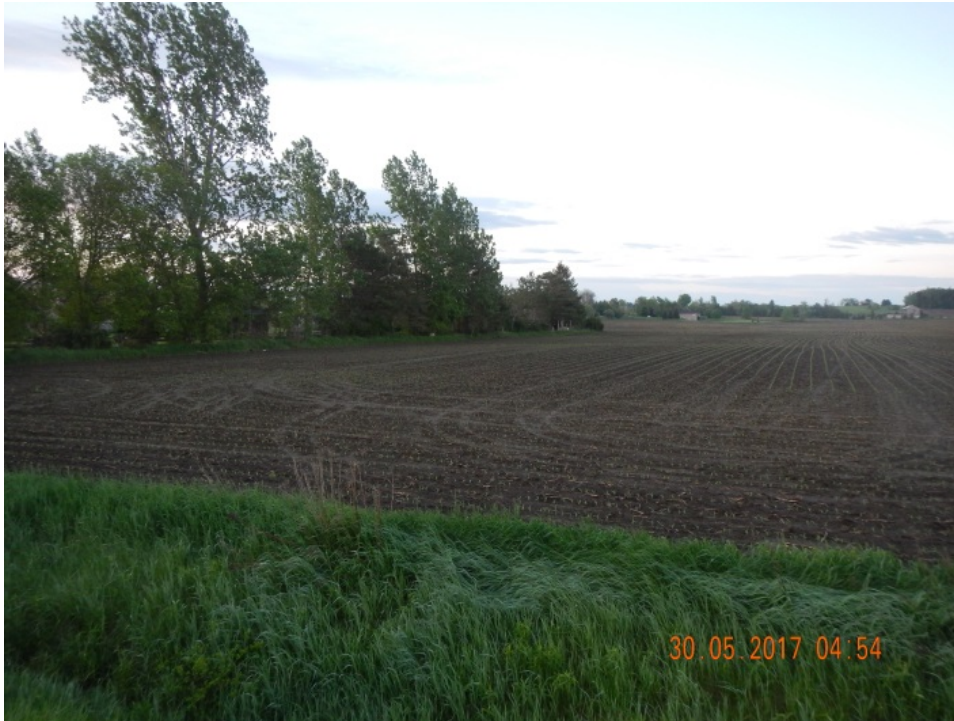
The southern field had very recently been planted with rows of corn, as confirmed by Wayland Farms Inc. (as seen in Figure 6). Corn is not consider a grass crop and is also not suitable for Bobolink and Eastern Meadowlark nesting. Currently there is no confirmed information regarding past crops that have been planted in this field; therefore it cannot be determined if at some point in the past Bobolink and Eastern Meadowlark did utilize the study area for nesting.

FIGURE 6 Southern Field Looking South from Highway 14 - Recently Planted Rows of Corn

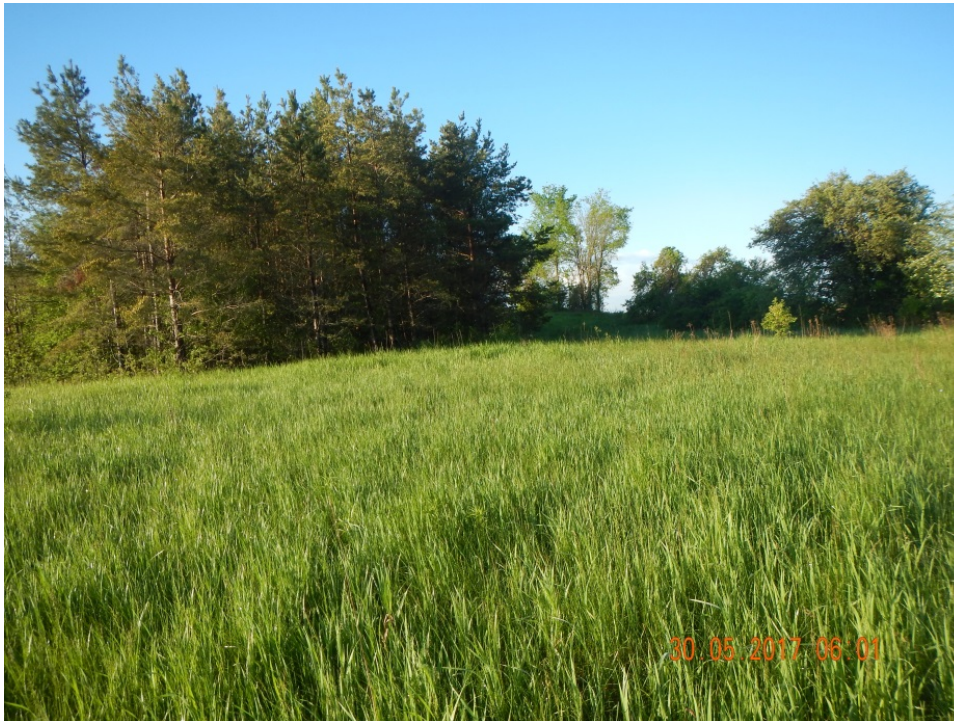
A point of interest within the southern field is a meadow area with a small quantity of trees in the north-west corner (POI #2) as seen in Figure 7. This area was further examined as it was a different habitat type than the agricultural field and due to the presence of long grasses in this area it had the potential for Bobolink and Eastern Meadowlark nesting. Upon investigation, 10 bird species were audibly observed in the meadow inclusion, including the Eastern Wood Pewee which is designated as provincially special concern. No Bobolink or Eastern Meadowlark was found utilizing the area.

FIGURE 7 Southern Field- Meadow Inclusion with Small Quantity of Trees Being Utilized by Birds

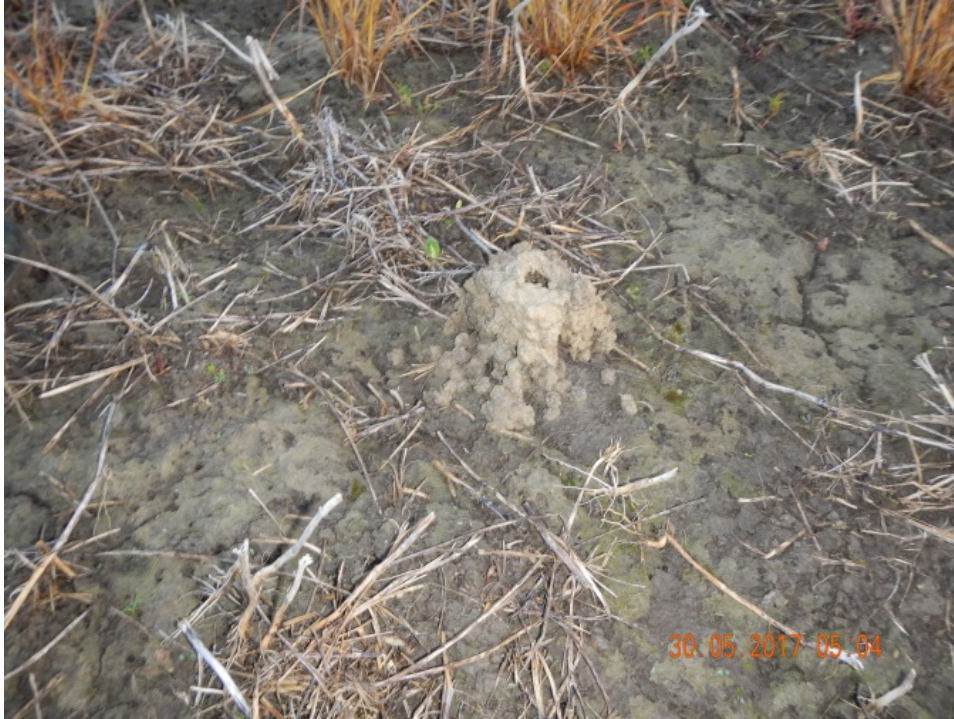
The Significant Wildlife Habitat (SWH) Criteria Schedule for Ecoregion 6E indicates that the presence of one or more individuals or their burrows in suitable meadow marsh, swamp, or moist terrestrial sites can be considered SWH (MNR, 2015). As per the Provincial Policy Statement (MAH, 2014) if any development or site alterations are to occur within the SWH, avoidance or mitigation options must be followed. However, the terrestrial burrow is located 250 m south of the proposed WWTP and forcemain routes and currently would not trigger any mitigation requirements.

FIGURE 8 Northern Field – Burrow (Chimney) Created by Terrestrial Crayfish

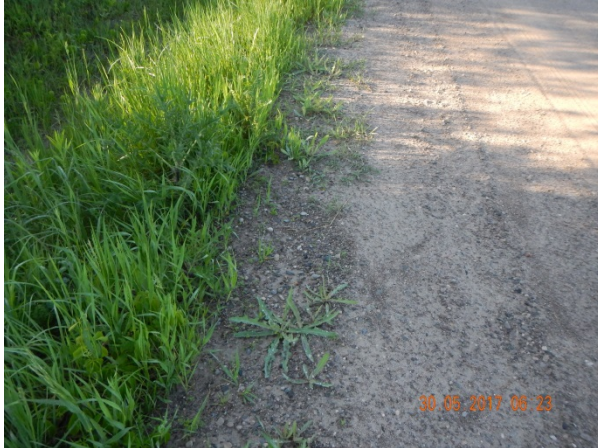
The assessment was completed along a 600 m section of Concession Road 8, adjacent to the wetland area. Each side of the road was examined for soft spots that may be the cover-up of a nest, as well as examined for any scratch marks that may indicate a turtle attempting to determine a nesting site. Figure 9 displays the conditions on the east side of the road and Figure 10 displays the conditions on the west side of the road.

FIGURE 9 East Road Shoulder Looking South

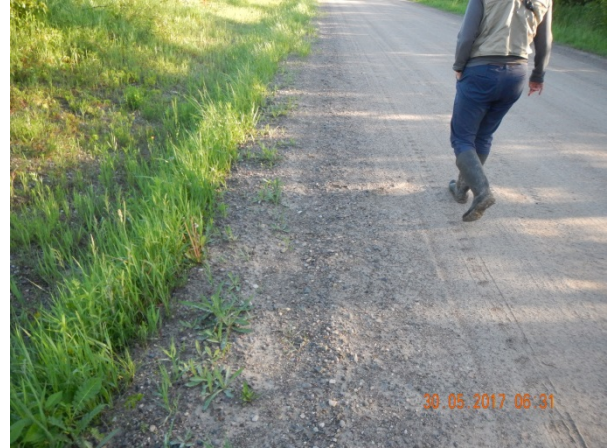
FIGURE 10 West Road Shoulder Looking North

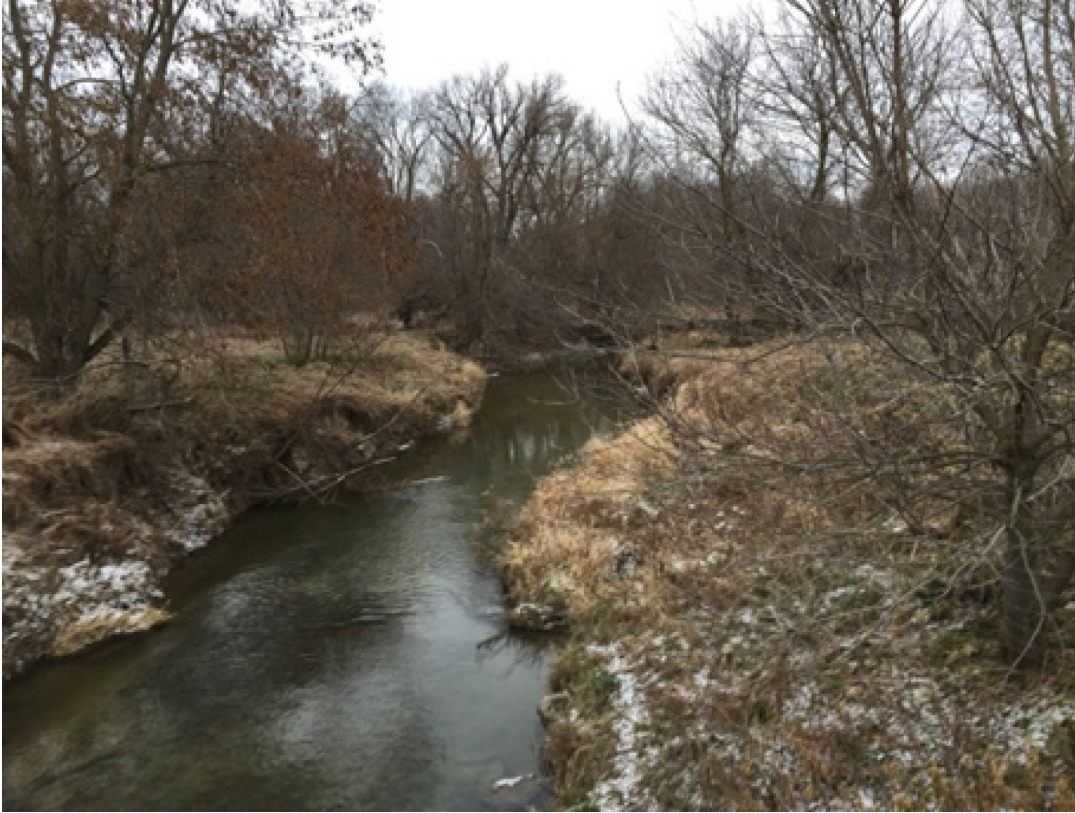
The alternative outfall to Bailey Creek would be located along a reach that exhibits moderate flow and exhibits a much larger bankfull width compared to the previous alternative outfall location, as a result of the drainage contribution provided by other tributaries of Bailey Creek. Although the immediate reach lacks overhead cover, its banks were observed to be relatively stable and well vegetated by grasses and meadow vegetation. From the alternative outfall location, Bailey Creek flows northerly to a large wooded parcel where it is surrounded by natural vegetation and assumes a natural form. This wooded parcel has been designated by both the MNRF and NVCA as an unevaluated wetland. According to the Fisheries Management Plan (2009), wetlands are generally known to provide fisheries habitat functions such as feeding, and refuge habitats in coldwater ecosystems. A photograph showing the general location of the alternative outfall location is provided in Figure 3.

FIGURE 3 Bailey Creek at Location of Alternative Outfall (View Downstream)

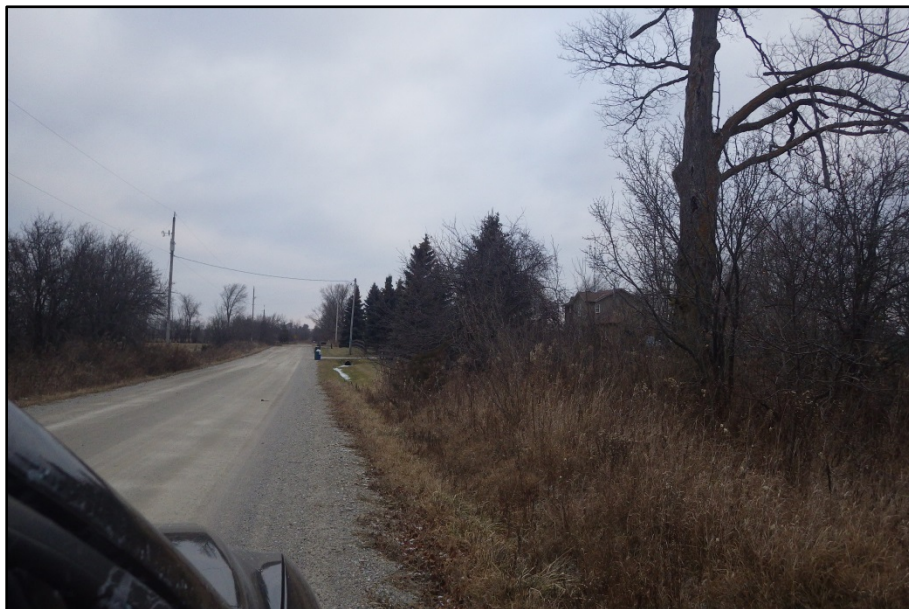
1. View facing north on Concession Road 8 (north of Highway 14). Sporadic deciduous and coniferous trees (public and private property) on both sides of the road.

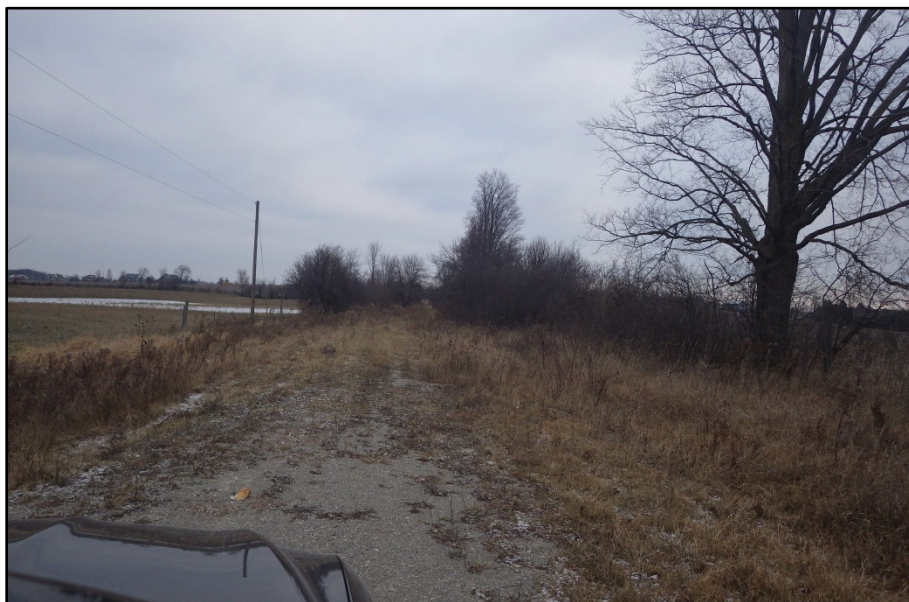
2. View looking north at the terminus of Concession Road 8 (north of Highway 14) where it becomes unopened allowance. Currently unable to access area. Observed mostly scrub and grasses within immediate area.

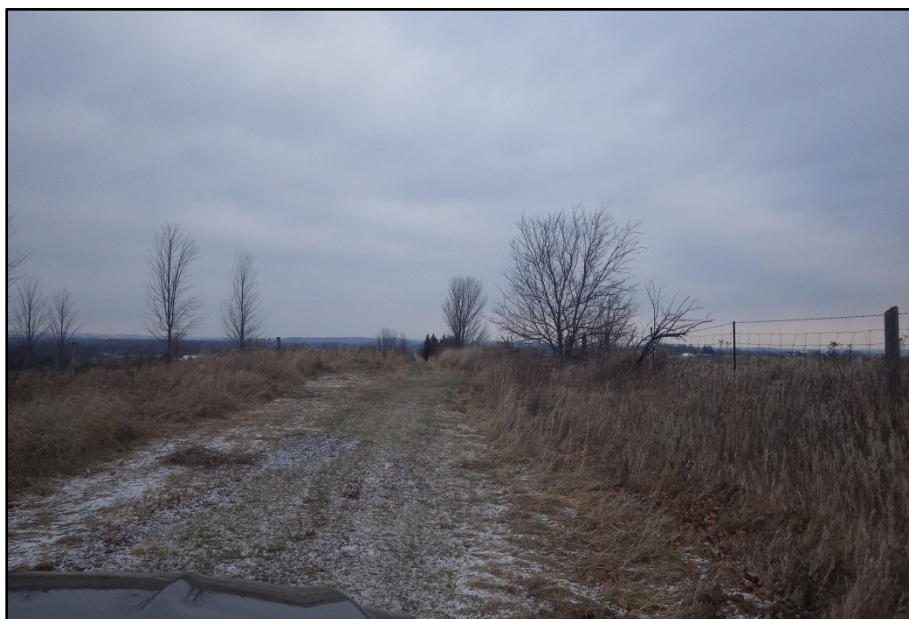
4. View looking north at terminus of Concession Road 8 (north of Keenansville Road). Currently unable to access area. Observed mostly grass species with sporadic shrubs and deciduous tree species.

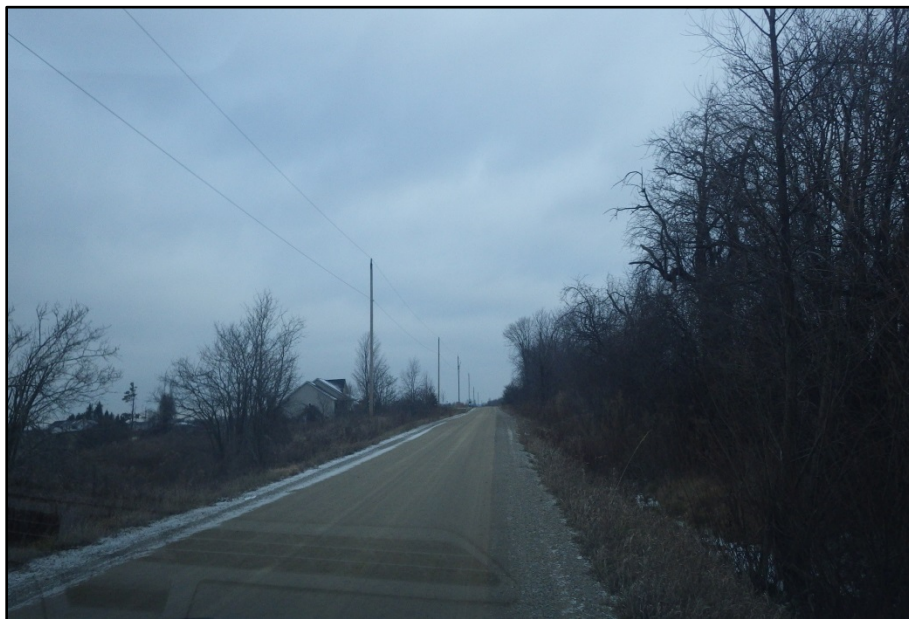
6. View looking north on Concession Road 8 (north of County Road 1). Thicket hedgerow along east side of road with sporadic shrubs along west side of road.

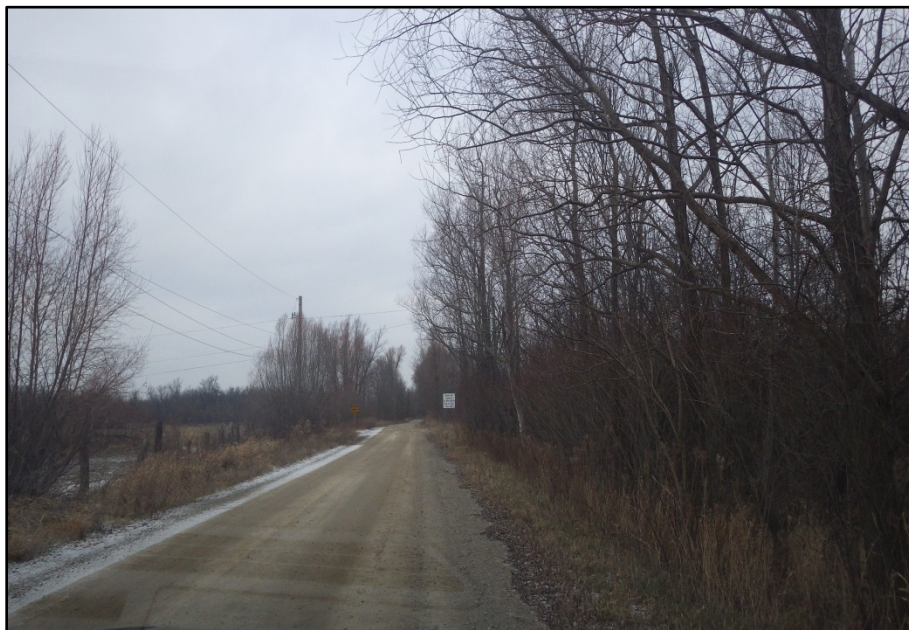
8. View looking north on Concession Road 8 (north of County Road 1). Woodland along east side of road with hydro poles along west side of road.
